Manhole Inspection Summary

Manhole # S25C__016MH

Insp Date: **8/2/07 9:36 AM**

Location Address: **329 CAREY ST**

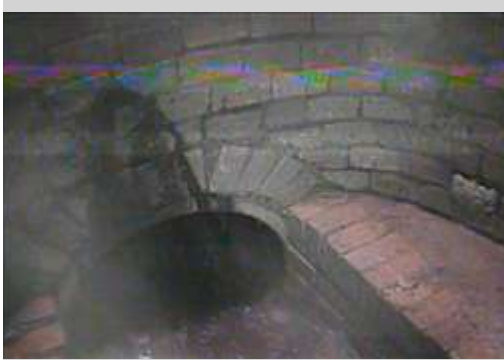
Defect 2

Condition: ☐ Sound ☐ Cracked ☐ Root Intrusion ☐ Loose Brick ☒ **Deteriorated**

Infiltration: ☐ None ☐ Joint ☐ Cracks ☐ Mortar ☐ Roots ☒ **Wall**

BARREL INFILTRATION AND
DETERIORATED BARREL

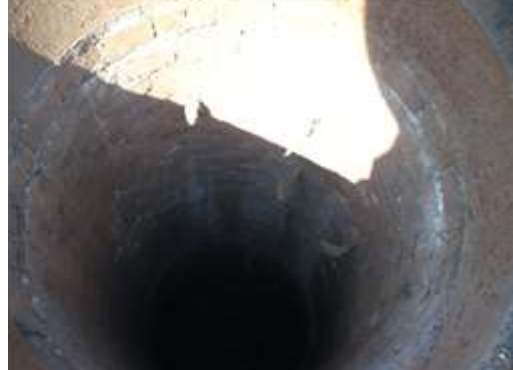
Defect 1

Steps Count: **4** Missing: **7** ☒ **Corroded**

MISSING AND CORRODED STEPS

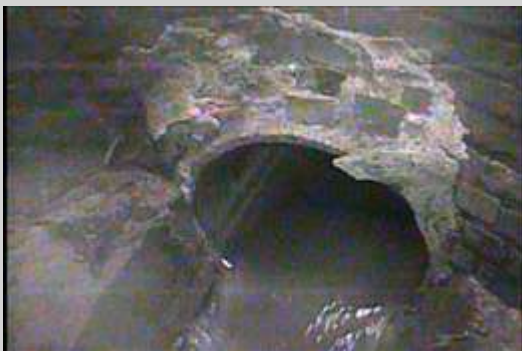
8 O'Clock Inflow

DETERIORATION OF THE BARREL
